The Hudson Armory

Historic Structure Report

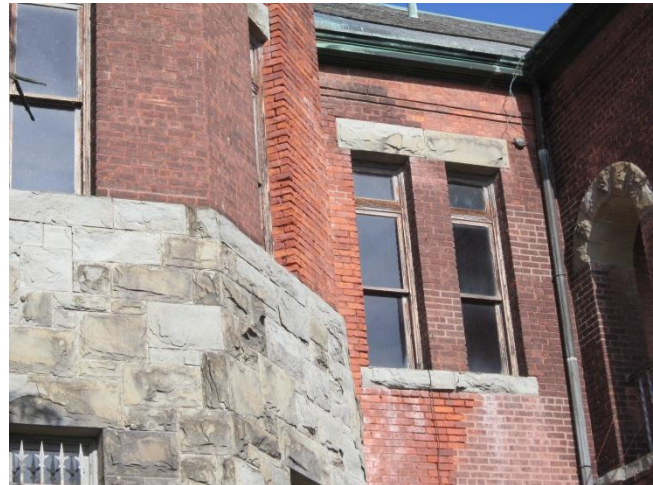
Brick and stone masonry in need of attention. Source: Author

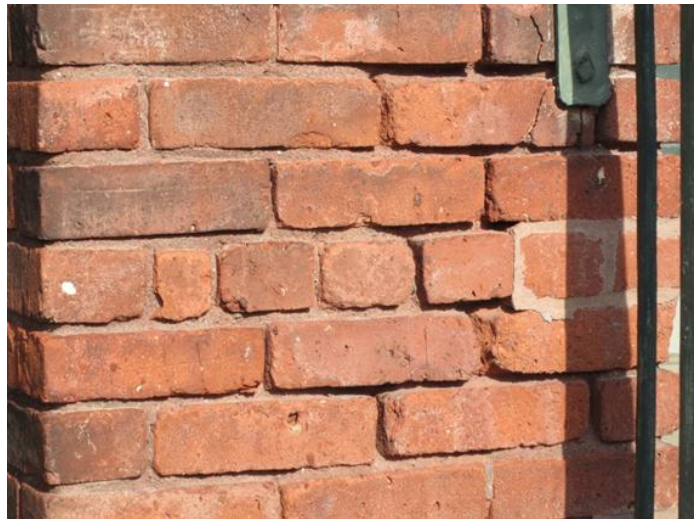
Deteriorated mortar joints, inappropriate repairs. Source: Author

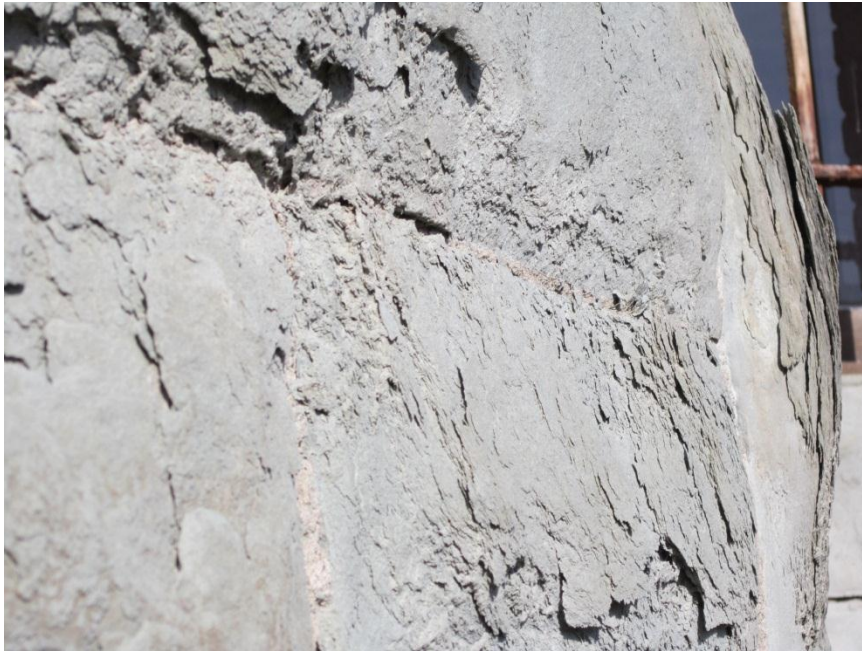
Sandstone is sugaring and delaminating. Source: Author

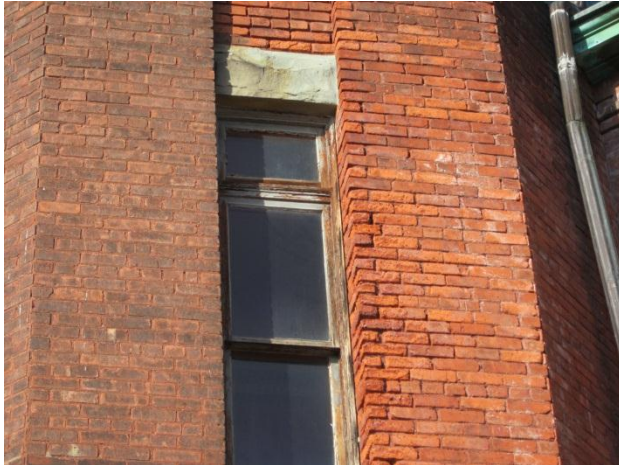
Paint coatings have failed and wood sash are directly exposed to the elements. Source: Author

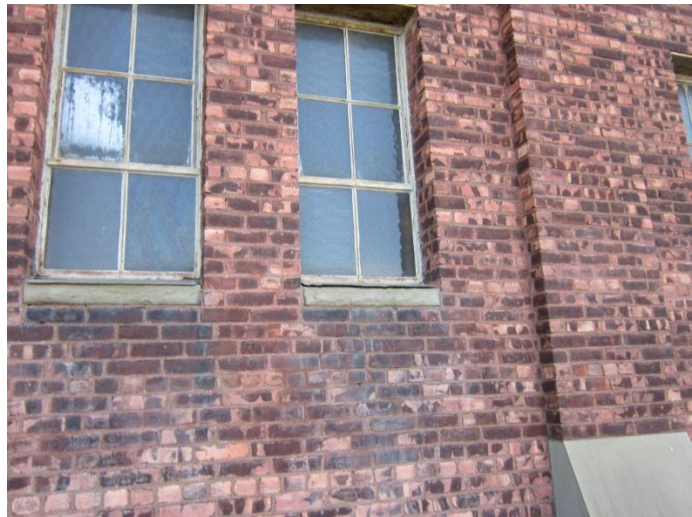
Steel windows have rusted and expanded. Source: Author

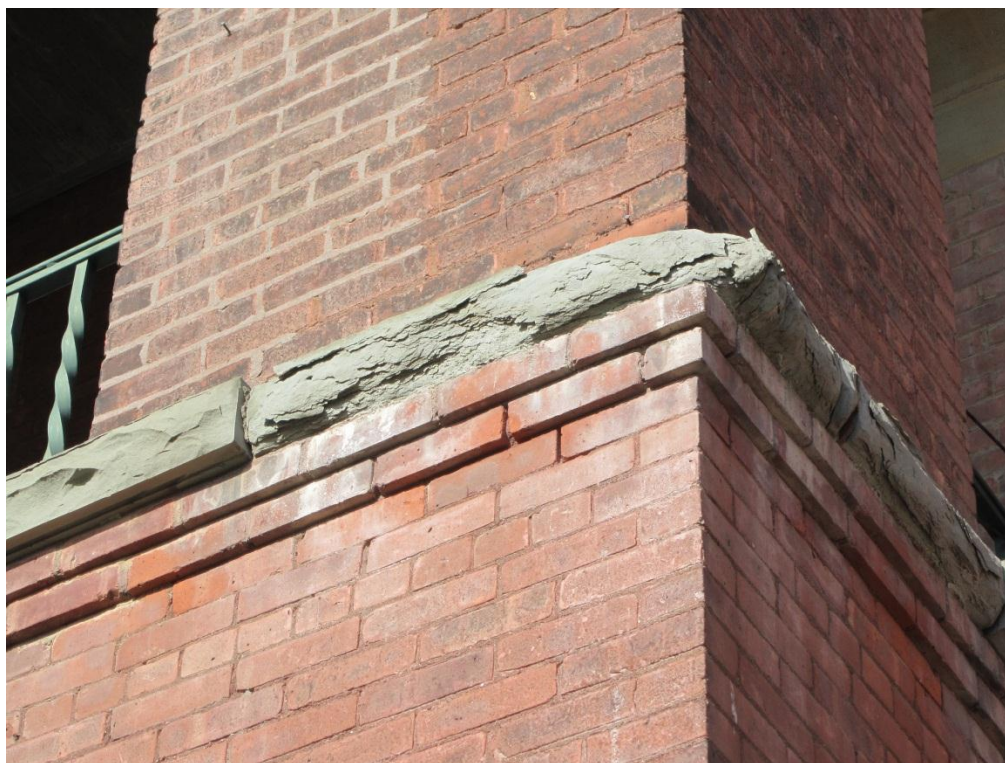
Deterioration of sandstone belt course. Source: Author

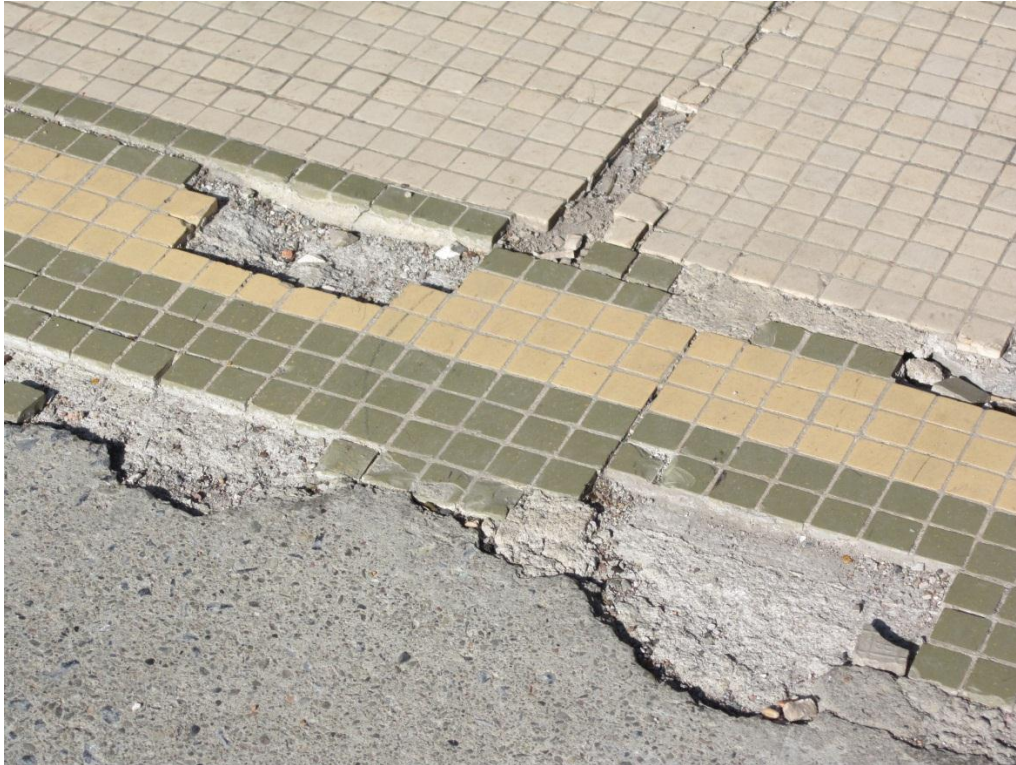
Missing tiles, font porch. Source: Author

Tile repairs ... The tiled deck of the porch and entry vestibule are missing dozens of original tiles. Replacement tiles should be acquired through salvage or custom ordered to match existing pieces. They should be set, grouted, and finished in a manner sympathetic to the original, adjacent units.

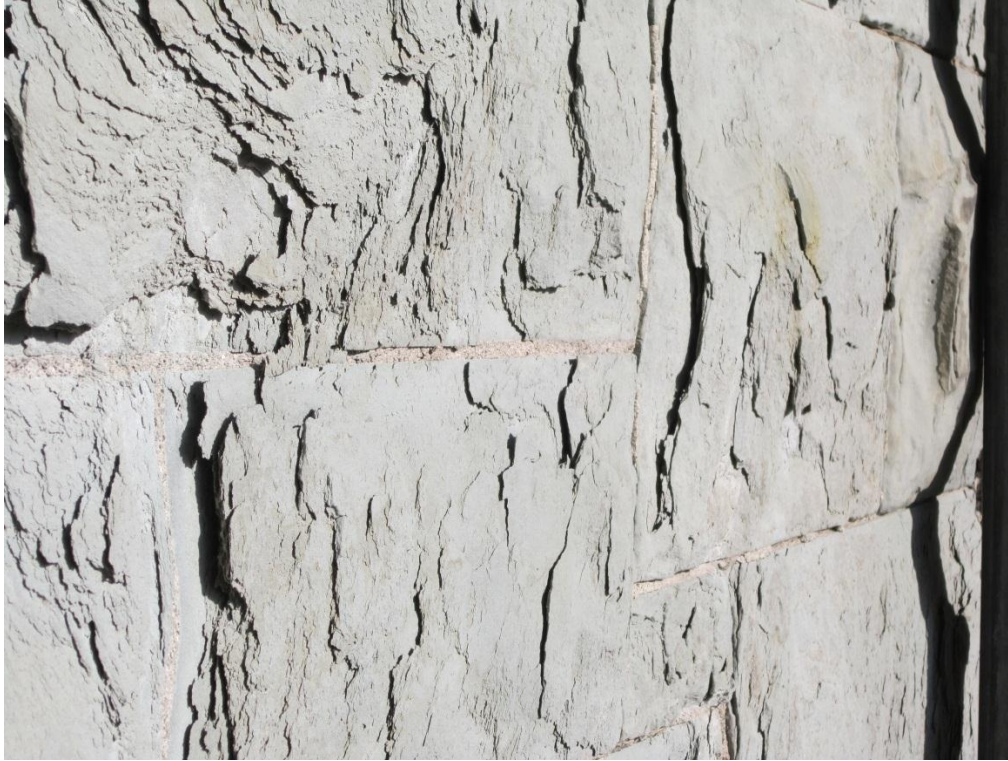
Stone restoration ... The blue sandstone used for the foundation, porch, arches, and architectural trim was, at some locations, set by the masons on the vertical side of the bedding plains. As a result, widespread delamination has occurred, as layers have exfoliated from the stones. At the front porch, in particular, massive sections of stone are completely gone. The problem is not new; some very decent stone patches can be seen and are holding up well. The failing layers of stone must be removed and the voids filled with contemporary stone patching compounds such as Cathedral Stone Products' JAHN restoration mortar. In some instances, the stone has deteriorated to the point where replacement is warranted. Replacement materials should be compared to existing units that are adjacent to the new work. A wide range of shades and tones are available for blue sandstone; samples must be provided and a proper match selected to provide an aesthetically pleasing finished product.

Delaminating sandstone, laid vertically on bedding planes. Source: Author

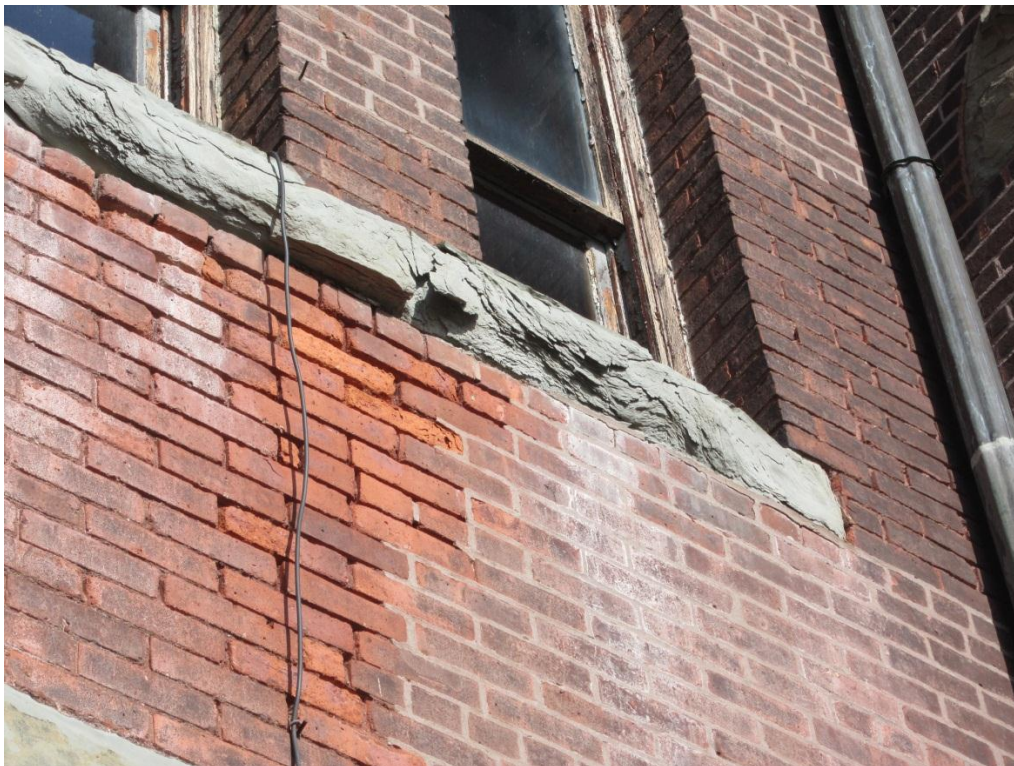
Deteriorating sandstone sill and mortar joints. Source: Author

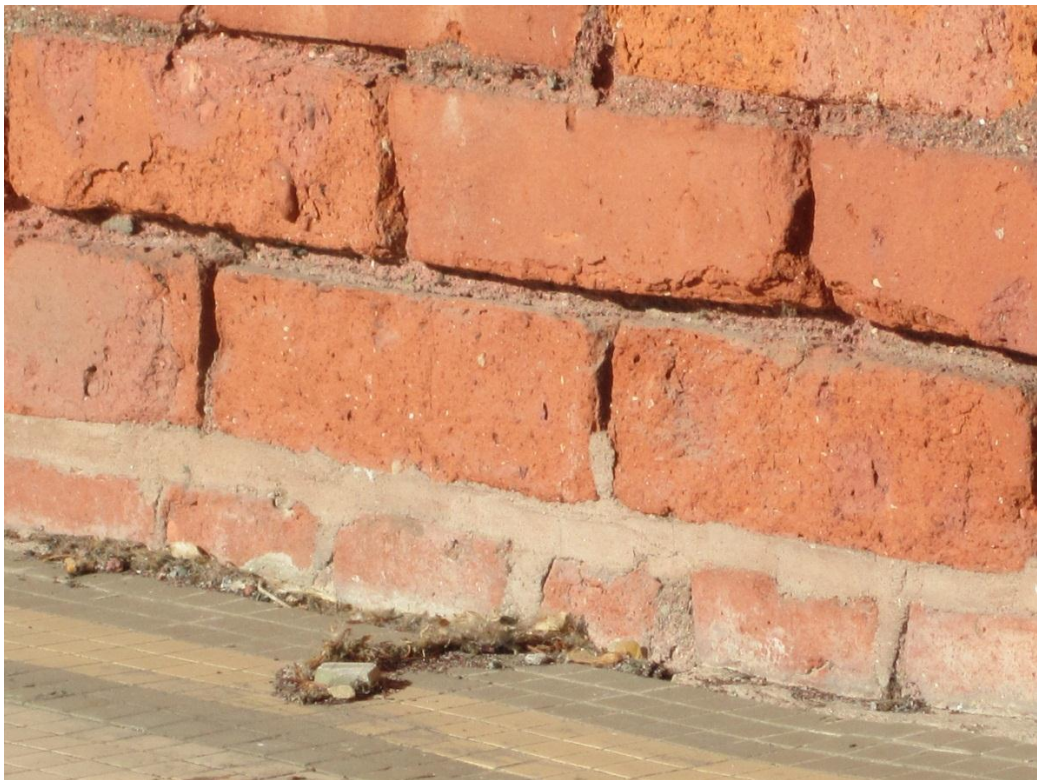
Capillary action has pitted brick on the front porch. Source: Author

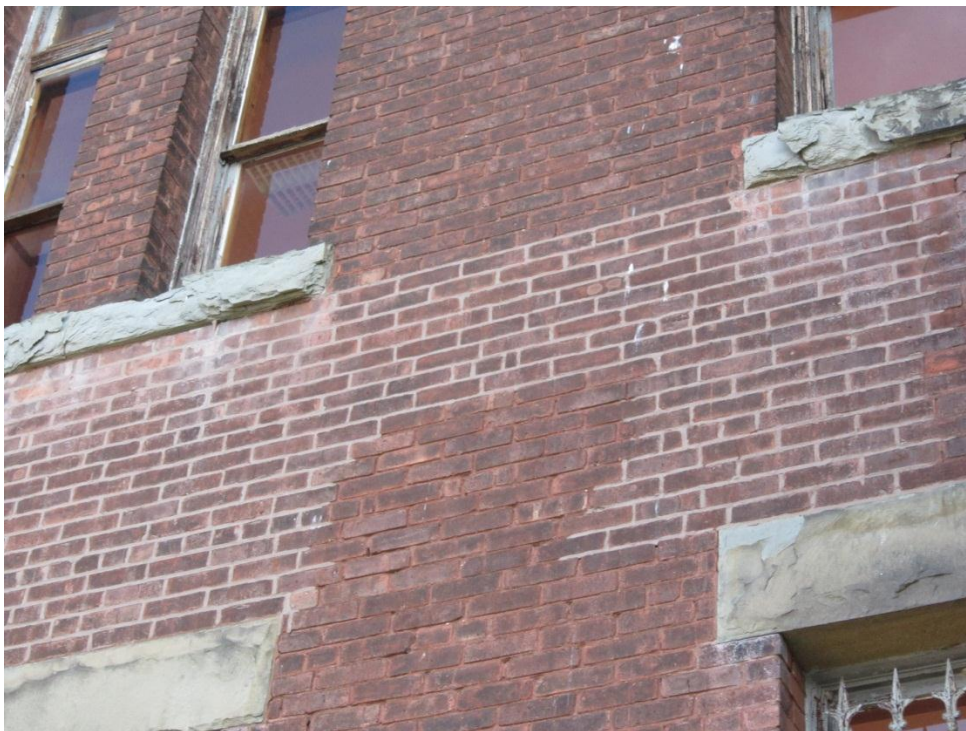
Inappropriate repointing work. Source: Author

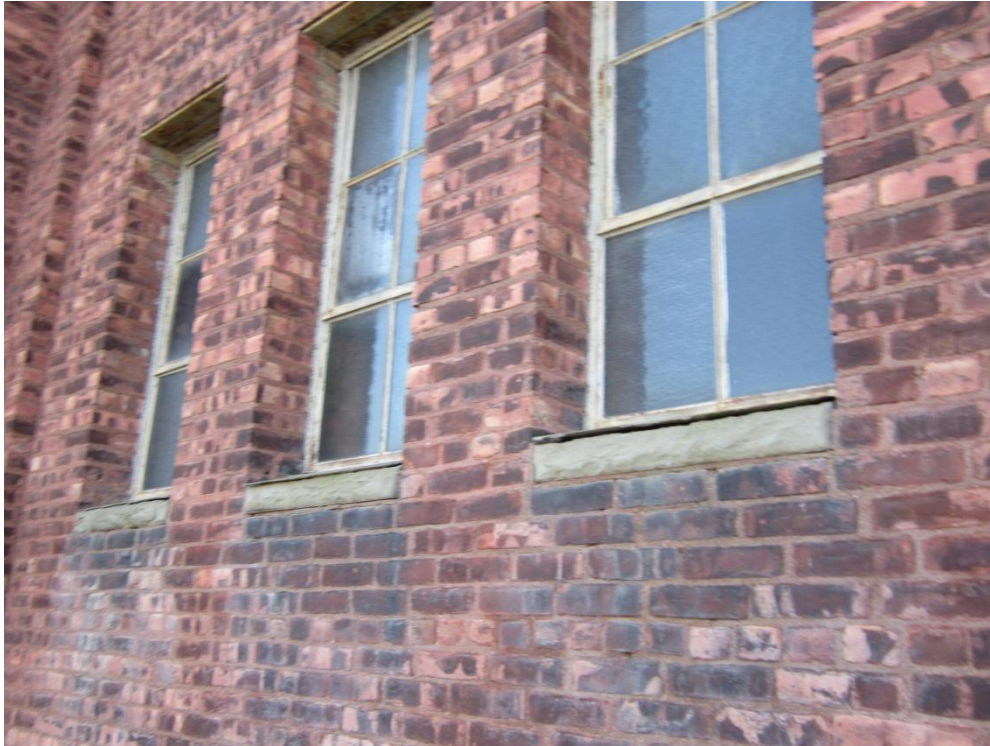
Steel windows have rusted and expanded, causing sills to delaminate. Source: Author

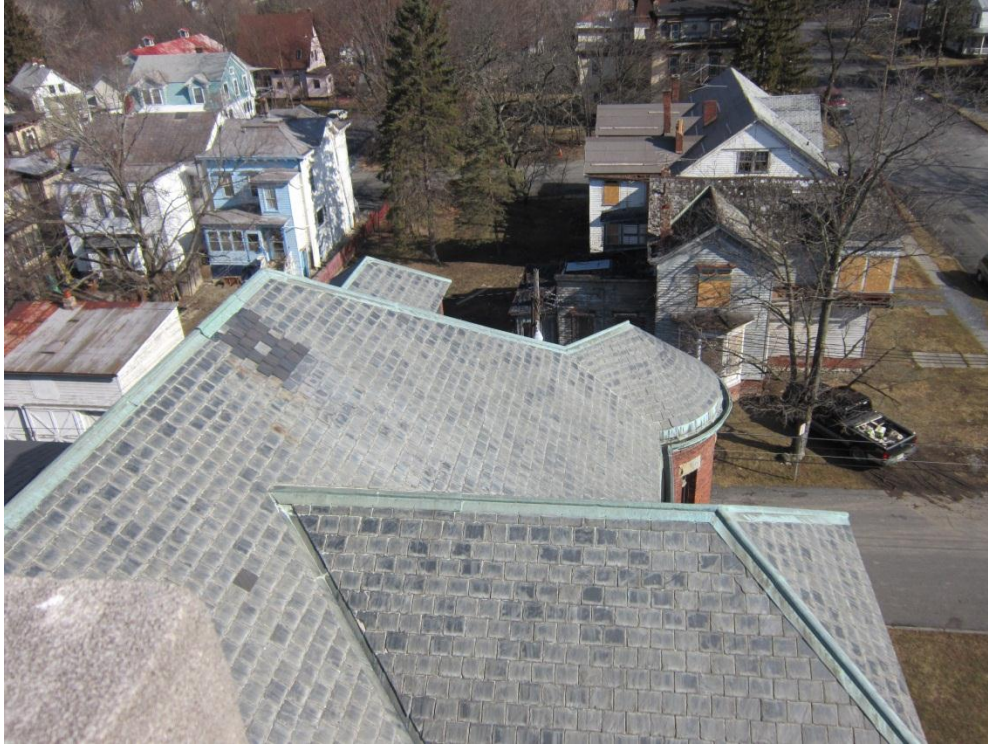
Administration building roof. Note missing chimney. Source: Author
