The Hudson Armory

Historic Structure Report

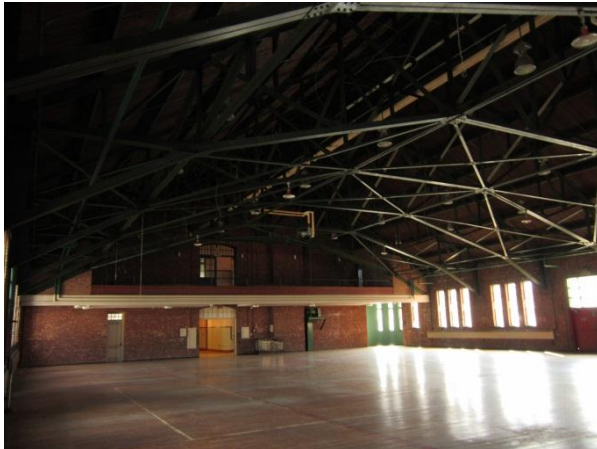
The drill shed. Source: Author

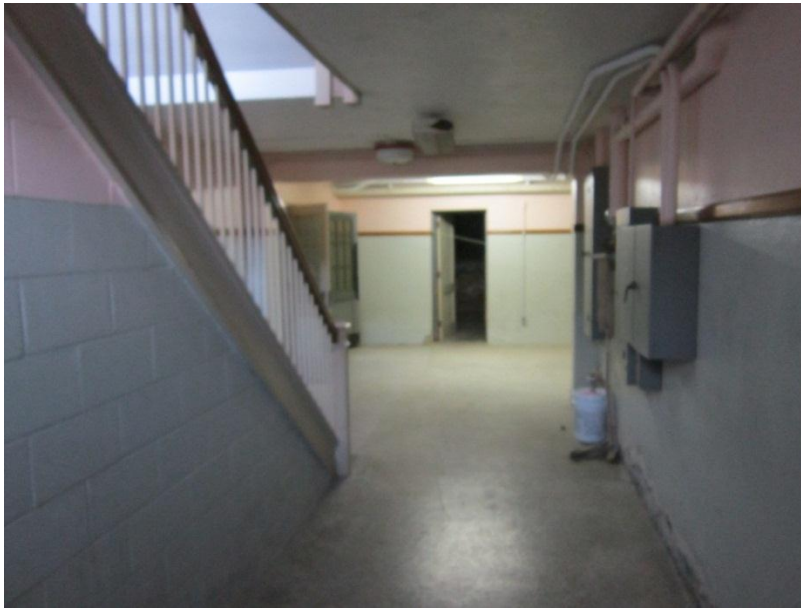
Room B01 Stair hall

The stair hallway in the basement is a largely utilitarian space, dominated by circuit breakers, steel doors and stairs. Several doorways enter adjoining spaces, the alarm room, the ammunition storage area, and the shooting range.

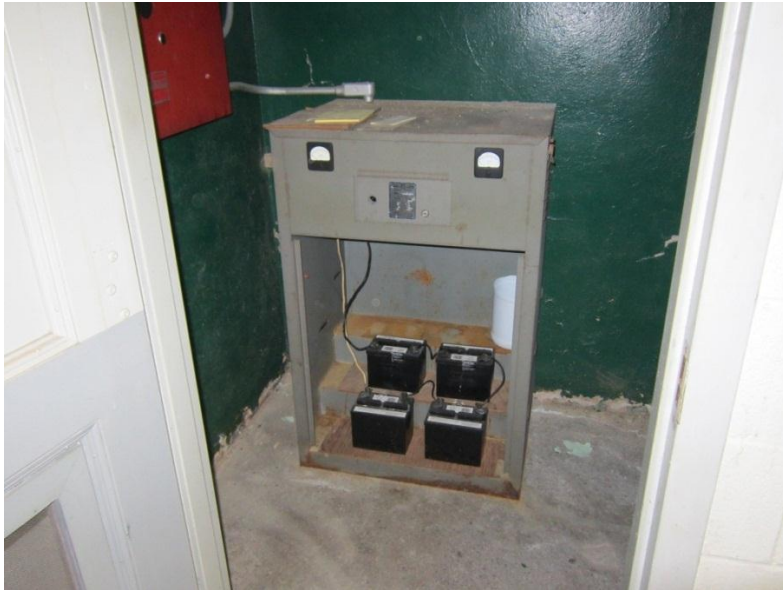
Room B02 Alarm closet

The alarm closet is located under the stairs and includes a battery backup system.

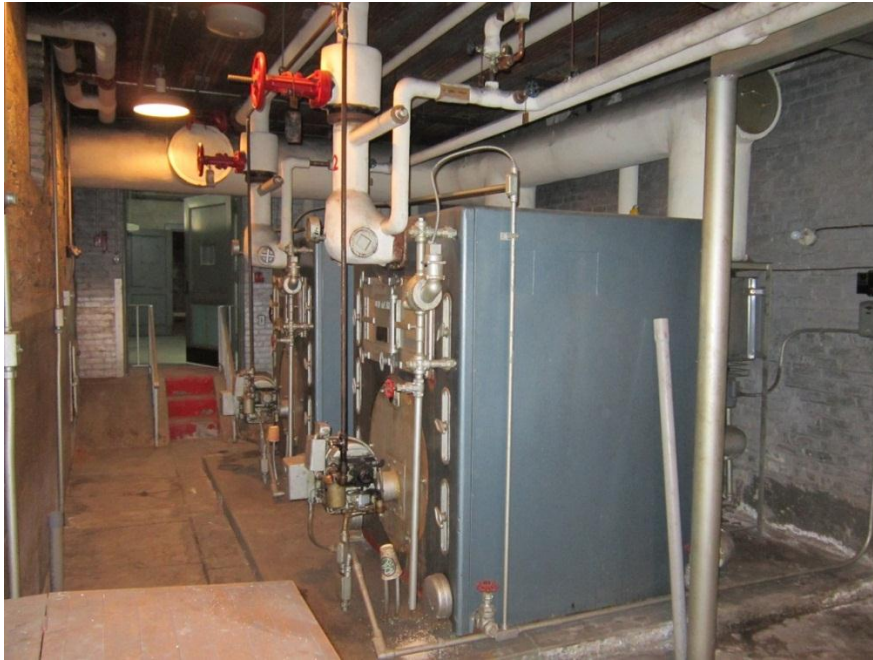
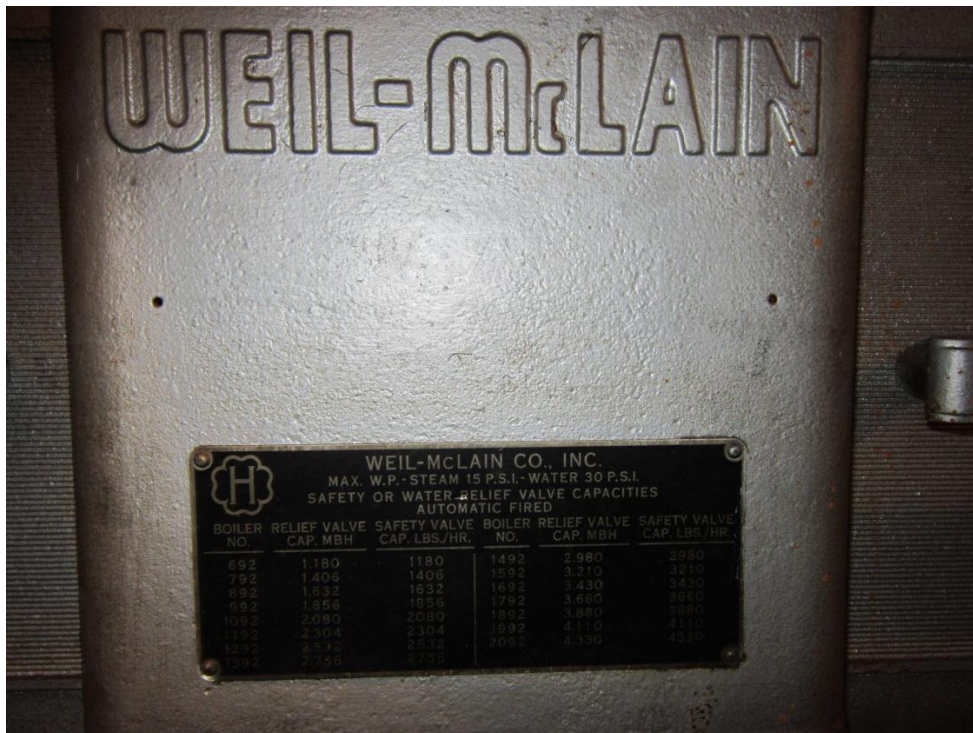
Room B09 Boiler room

The boiler room is dominated by two massive, Weil-McLain oil burners. During the winter, the furnaces burn seventeen gallons of oil per hour.

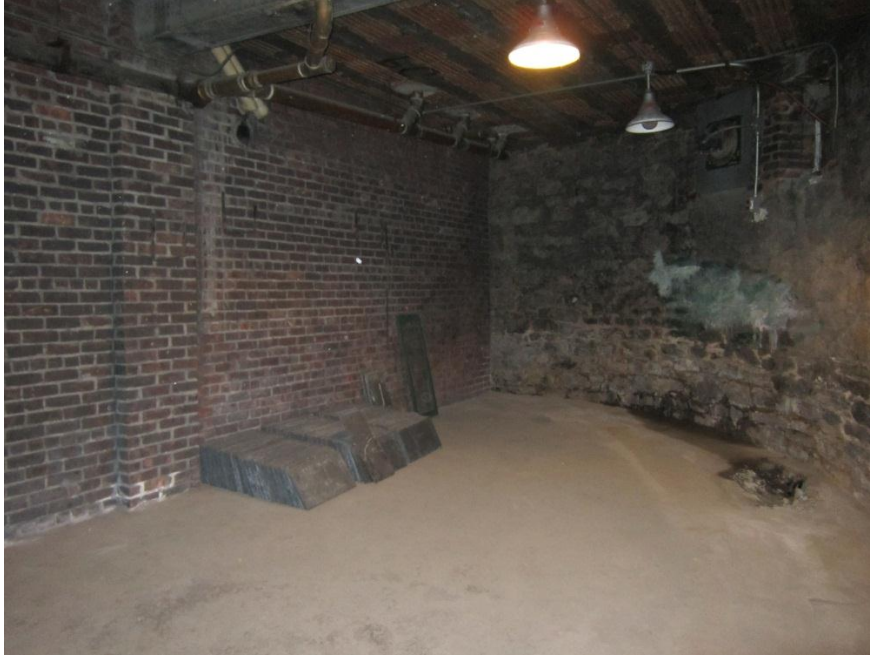
Room B12 Coal bin

The coal bin has been unused since after 1962, when it was identified on plans as such. It can be surmised that the existing, oil-fed burners were installed at some time after.

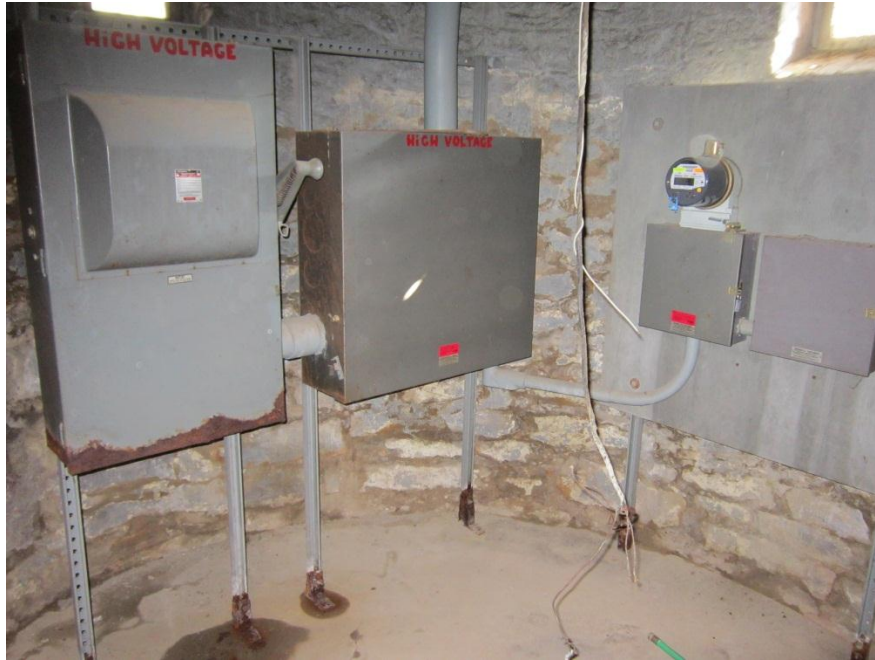
Room B14 Electrical service

The 400 amp electrical service is located in the basement below the northeast tower.

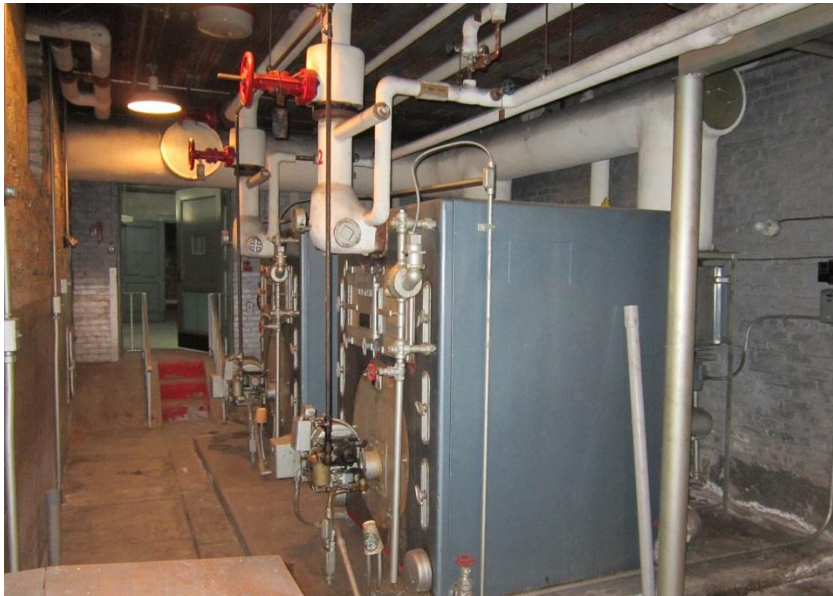
The boiler room as it exists in February of 2012. Source: Author

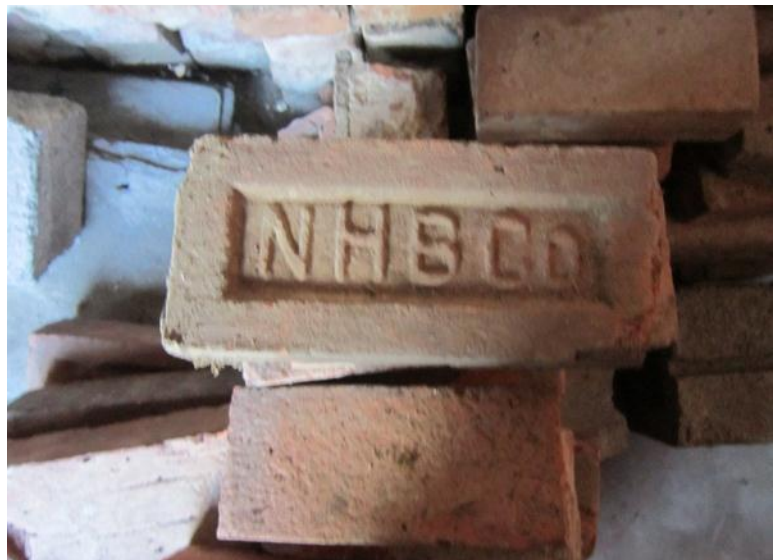
The frog indicates manufacture by the Newton Hook Brick Company, an outfit that operated several miles north of the armory. Source: Author

the same sandstone with rusticated faces. The sandstone is set in the same mortar as the limestone. The walls of the Hudson Armory are composed of a relatively uniform, red sanded brick. At the turn of the century, the Hudson River Valley was flush with prolific brick making companies. The brick units sampled indicated NHBCo. The Newton Hook Brick Company was in operation for many years about eight miles north of the City of Hudson. The brick are laid in American bond, and the mortar is very hard with crushed red brick as a component of the aggregate. The brick buttresses are capped with a fine-grained limestone; radial saw marks are visible on the sides of each. While not typically discussed under masonry analysis, the slate roofing tiles appear to be a thick, Pennsylvania black. The field slate measure 10" x 20" and are 1/4" to 3/8" in thickness. While in generally good condition, a fair degree of hazing is evident, typical of the gypsum deposits that frequently leach out of Pennsylvania slate.

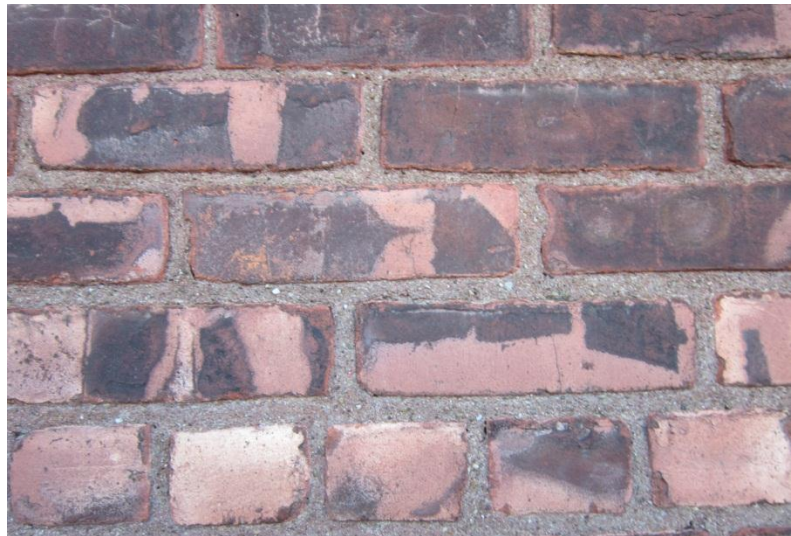
Detail of brick masonry. Source: Author

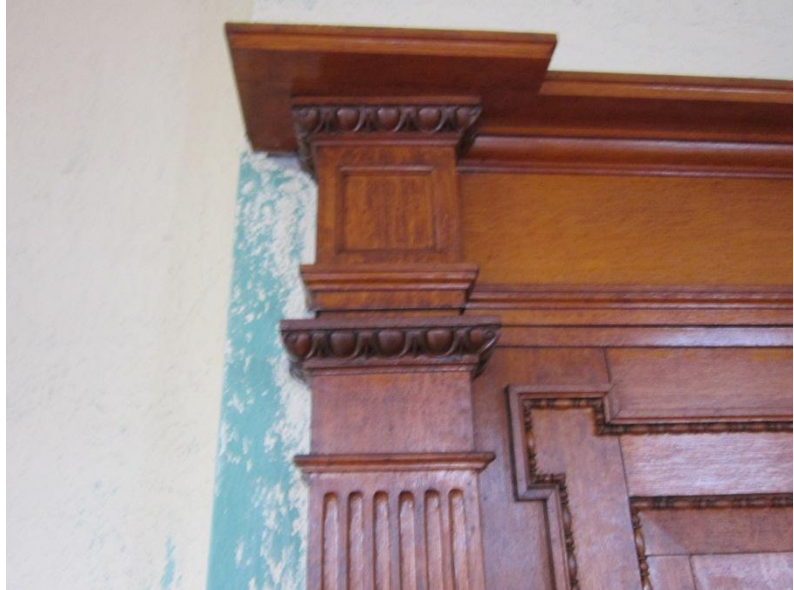
The exquisite detail of interior mill work is in pristine condition. Source: Author

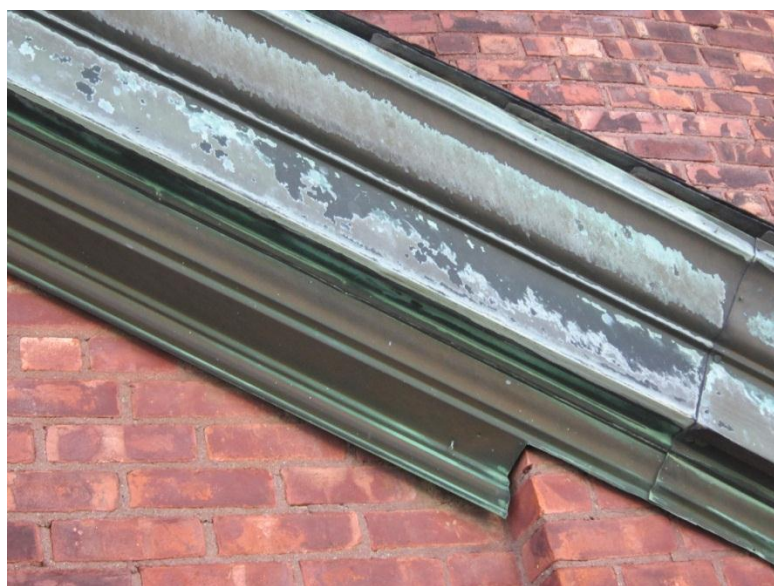
Copper sheet metal cornice decorates the rakes of the roof. Source: Author

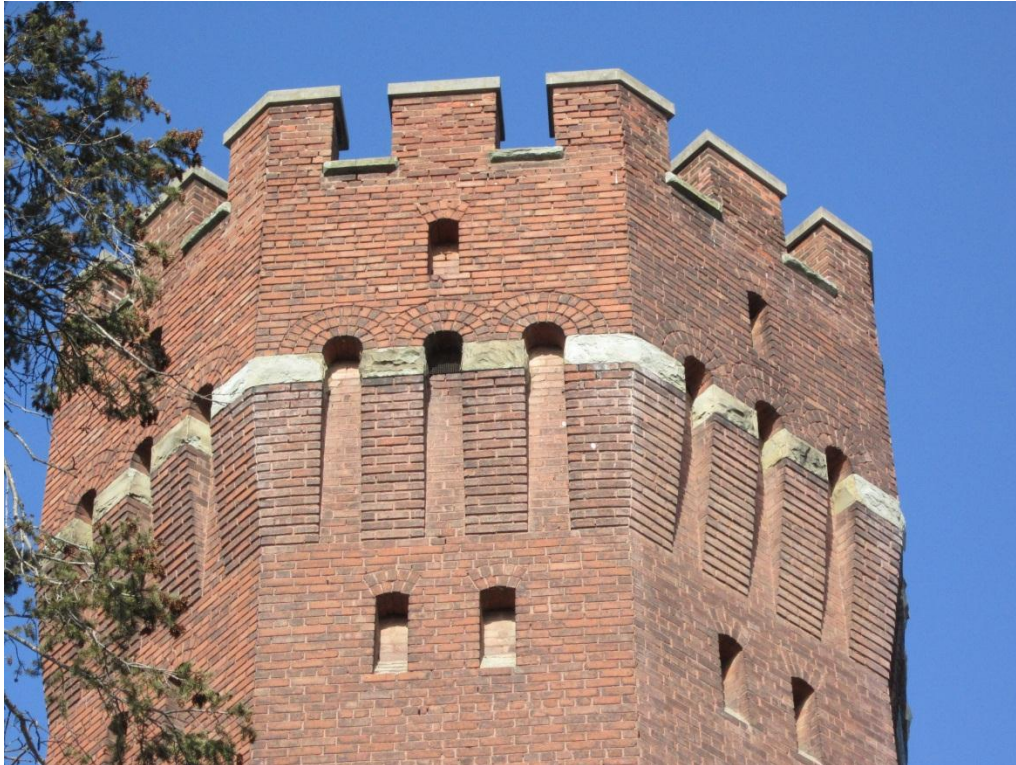
Detail of machicolated crenellation. Source: Author

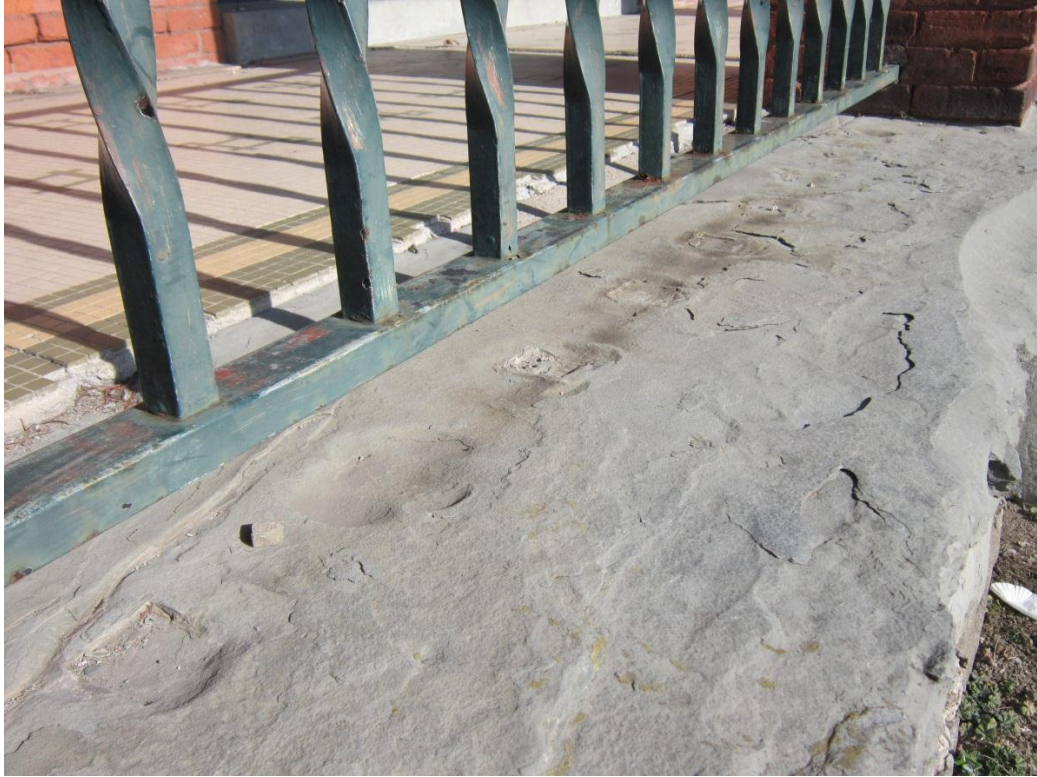
Evidence of the original stone balustrade. Source: Author

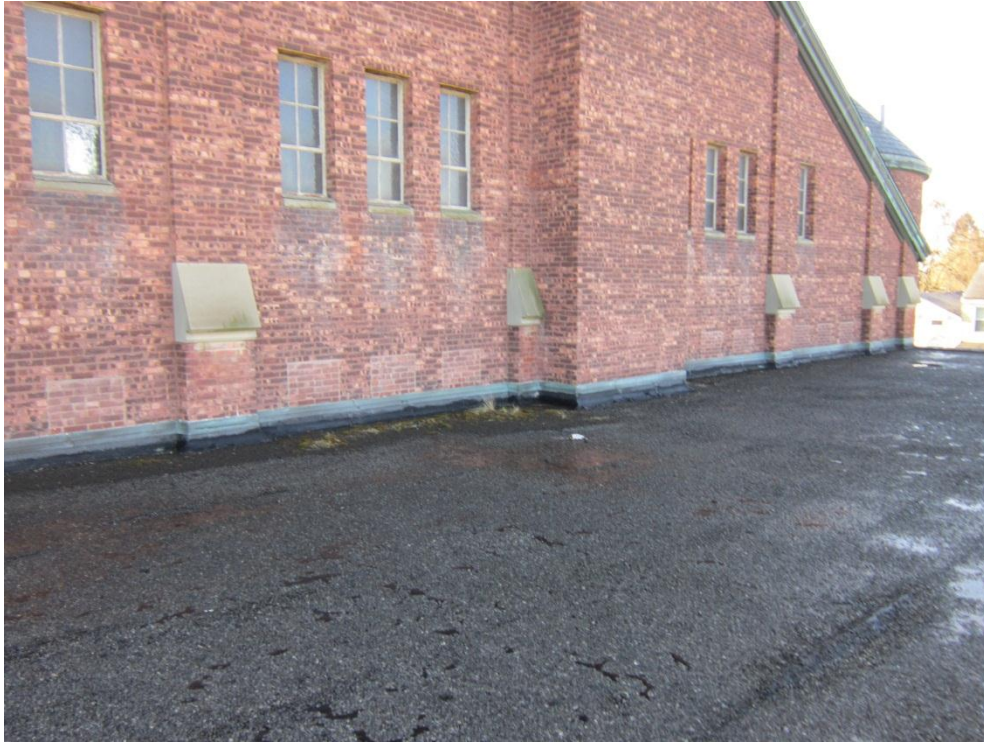
Motor vehicle storage addition rooftop. Source: Author

Flat roofing replacement, over motor vehicle storage addition, 2960 SF @ \$8.80/SF = \$26,048

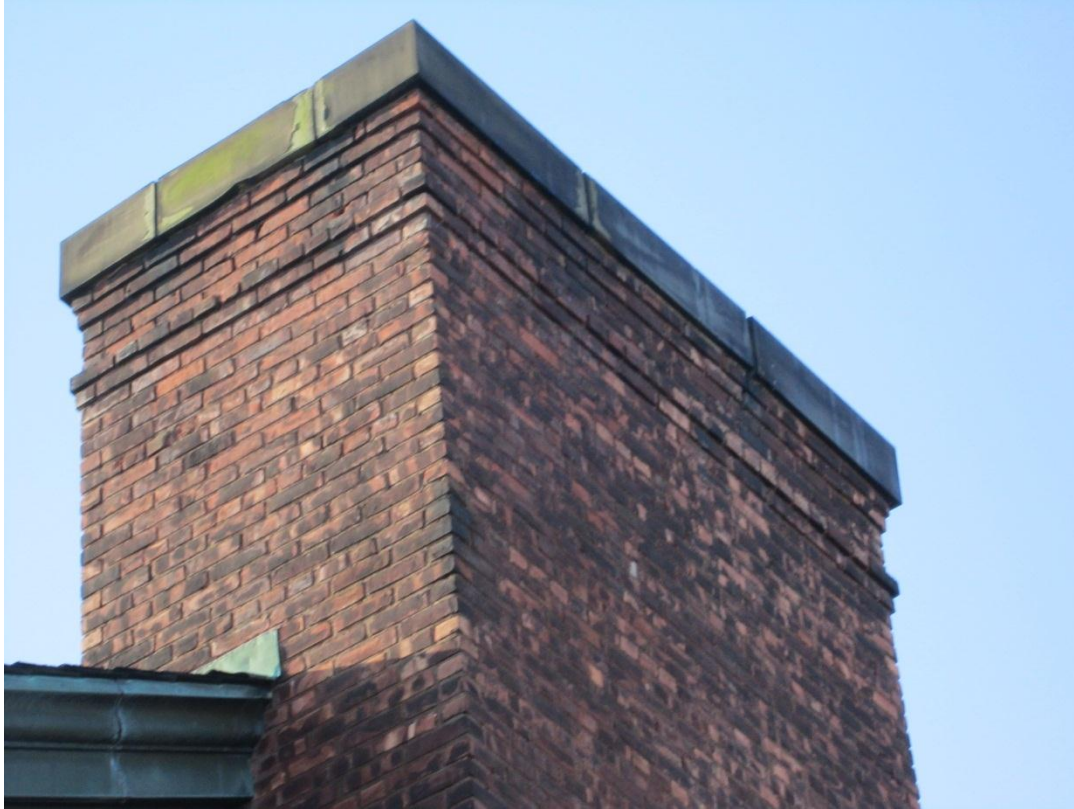
Large chimney stack at western end of building. Source: Author

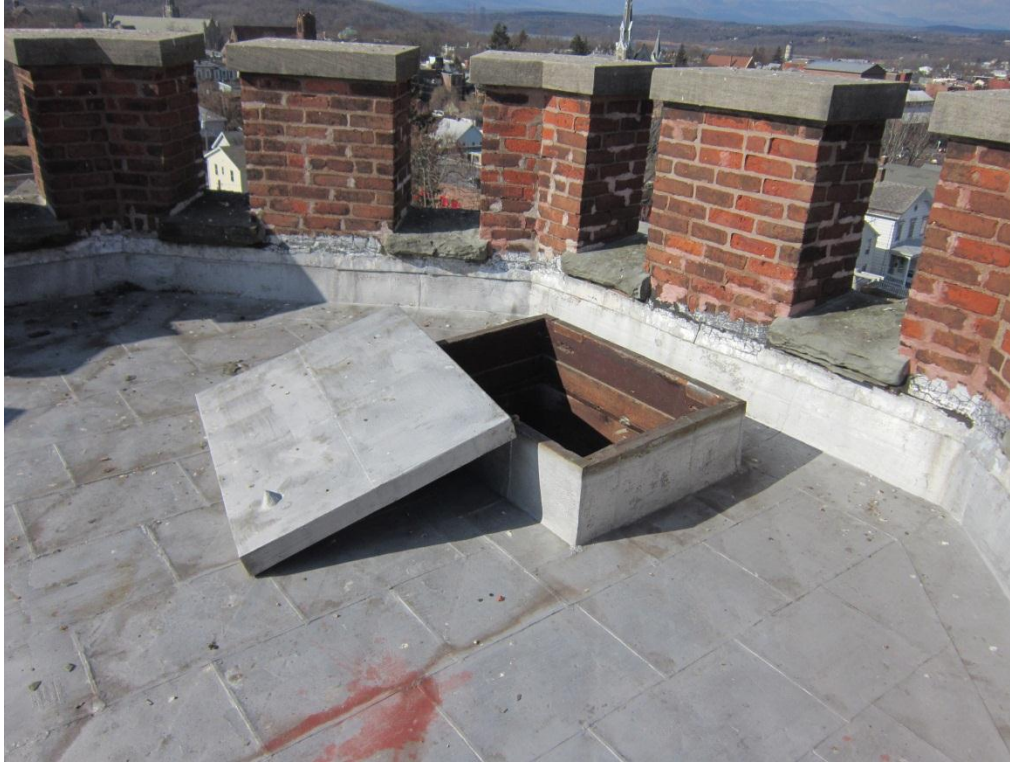
Crenellation and tower roof. Source: Author
